# Comparison of wear resistance of induction-hardened and gas-nitrided samples in the abrasive mass motion

Source / Izvornik: **Metalurgija, 2023, 62, 285 - 288**

# COMPARISON OF WEAR RESISTANCE OF INDUCTION-HARDENED AND GAS-NITRIDED SAMPLES IN THE ABRASIVE MASS MOTION

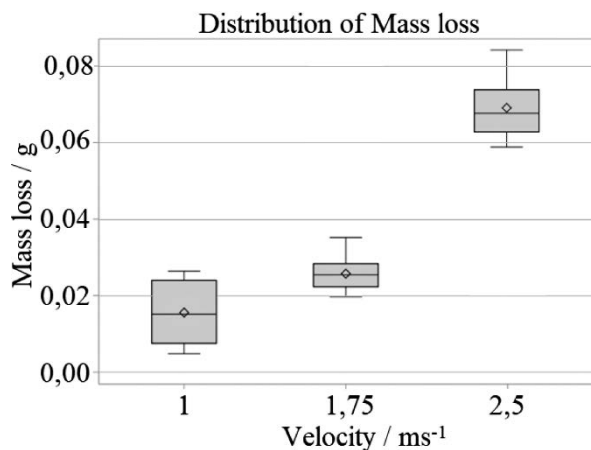
Figure 4 Distribution of mass loss depending on sample velocity

The distribution of data referring to mass losses depending on levels of input parameters (sample velocity and impact angle) and referring to material condition is shown in Figures 4, 5 and 6. It is noticed that the distribution of mass loss was the highest when depending on the impact angle and material condition. As seen in the Figure 4, the increase in sample velocity caused the increase in mass loss. Such result is a consequence of increased impact energy between the abrasive particles and the worn surface, which leads to increased mass loss.

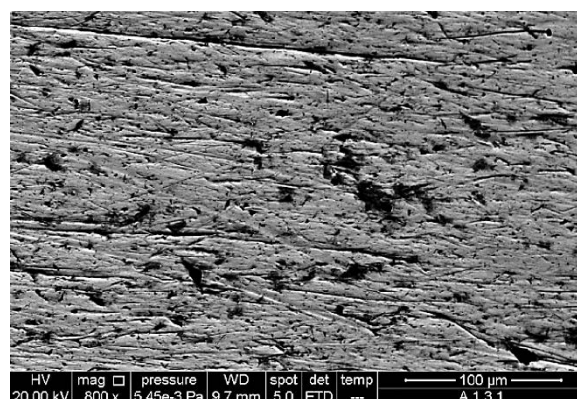
Figure 7 SEM wear of induction-hardened samples

The Figures 7 and 8 show scanning electron microscopy (SEM) recording of the wear paths, proving that induction-hardened samples had higher mass loss than gas-nitrided samples, as well as higher mass loss at the highest sample velocity (2,5 m/s) and at lower impact angle. As presented in the Figure 7, clear evidence of abrasive wear was present in form of tiny rills and holes.
