# Comparison of wear resistance of induction-hardened and gas-nitrided samples in the abrasive mass motion

Source / Izvornik: **Metalurgija, 2023, 62, 285 - 288**

**Journal article, Published version**

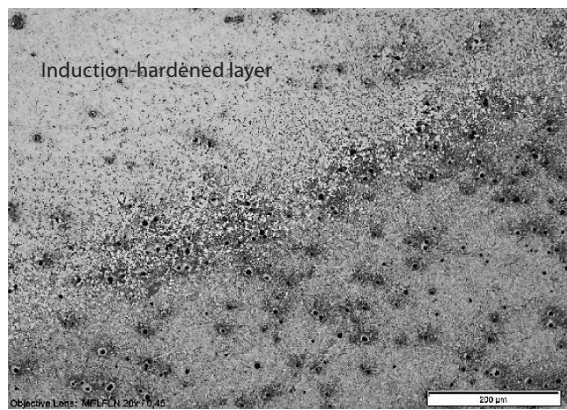
**Figure 1** Microstructure of induction-hardened sample

Induction hardening of samples was performed on a HGL-400 device manufactured by Fritz Düsseldorf GmbH, with a shift of 3 m/min and direct water-jet cooling to a room temperature. The Figure 1 presents the microstructure of induction-hardened sample.

The sample surface hardness was 60 HRC, while the average microhardness at cross section was 678 HV<sub>0,1</sub> measured to a depth of 0,6 mm, which is the effective thickness of the hardened layer.

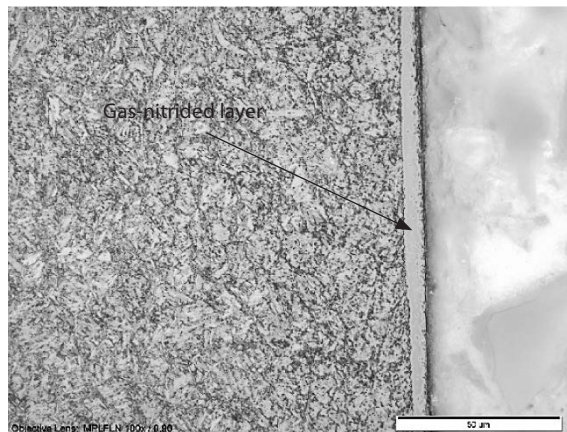
**Figure 2** Microstructure of gas-nitrided sample

The process was carried out in a gas nitriding furnace in an atmosphere rich in ammonia (NH<sub>3</sub>), at a temperature of 510 °C for 20 hours. Surface hardness of the gas-nitrided samples was 58 HRC. The average microhardness at the sample cross section was 631 HV<sub>0,1</sub>, measured to a depth of 0,3 mm, which is the effective thickness of the hardened layer. Microstructure of the gas-nitrided sample is shown in Figure 2.

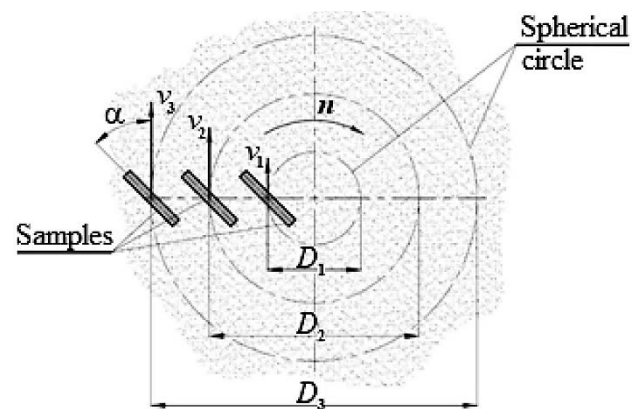
**Figure 3** Schematic presentation of kinematic quantities in the experiment

The wear test was performed on an abrasive mass wear device in which samples were immersed in the abrasive mass and rotated at a constant velocity of  $n = 58 \text{ min}^{-1}$ . Motion speed of samples was 1,0, 1,75 and 2,5 m/s, and impact angles of abrasive mass and worn surface were 30° and 60° ( $\alpha$  – the angle show in figure 3). Stated parameters were selected because of their similarity with common agrotechnical methods of tillage. The Figure 3 presents kinematic quantities in the wear experiment, by showing that the samples were placed on a precisely determined diameter of inscribed circle ( $D$ ), which they move along, and that the sample velocity ( $v$ ) was calculated according to the expression for peripheral velocity.

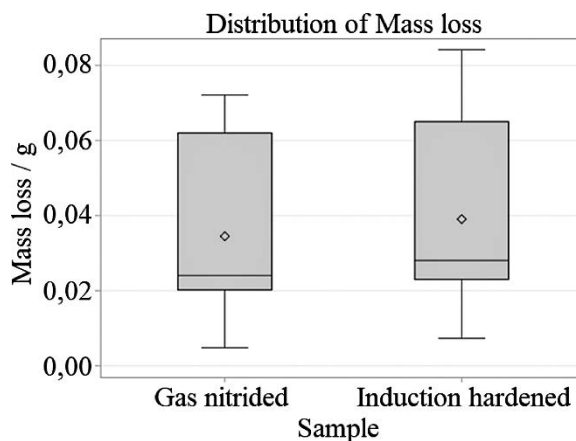
Figure 6 Distribution of mass loss depending on material condition

The Figure 6 shows that induction-hardened samples exhibited a slightly higher mass loss than gas-nitrided samples. Due to lower surface hardness, gas-nitrided samples were better at absorption of the impact energy between the abrasive particles and the worn surface, which led to lesser mass loss of these samples.

The distribution of data referring to mass losses depending on levels of input parameters (sample velocity and impact angle) and referring to material condition is shown in Figures 4, 5 and 6. It is noticed that the distribution of mass loss was the highest when depending on the impact angle and material condition. As seen in the Figure 4, the increase in sample velocity caused the increase in mass loss. Such result is a consequence of increased impact energy between the abrasive particles and the worn surface, which leads to increased mass loss.

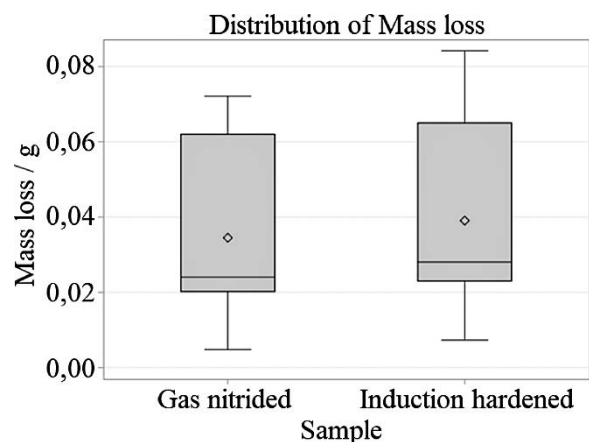
Figure 5 Distribution of mass loss depending on impact angle

As of the Figure 5, it is clear that the increase of impact angle reduces the mass loss, which is a consequence of shorter contact between the abrasive particles and the worn surface at a higher impact angle.

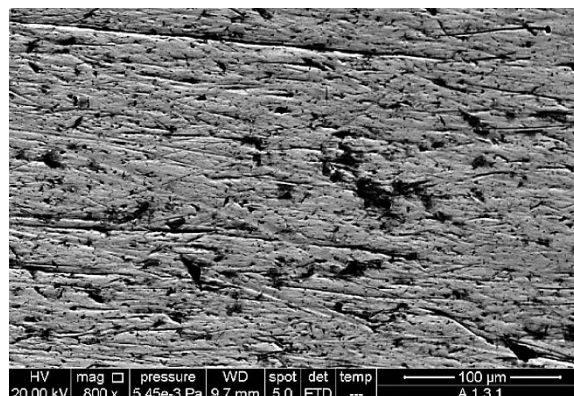
Figure 7 SEM wear of induction-hardened samples

The Figures 7 and 8 show scanning electron microscopy (SEM) recording of the wear paths, proving that induction-hardened samples had higher mass loss than gas-nitrided samples, as well as higher mass loss at the highest sample velocity (2,5 m/s) and at lower impact angle. As presented in the Figure 7, clear evidence of abrasive wear was present in form of tiny rills and holes.
