Vidaković, I.; Heffer, G.; Špada, V.; Samardžić, Iva

# COMPARISON OF WEAR RESISTANCE OF INDUCTION-HARDENED AND GAS-NITRIDED SAMPLES IN THE ABRASIVE MASS MOTION

Preliminary Note – Prethodno priopćenje

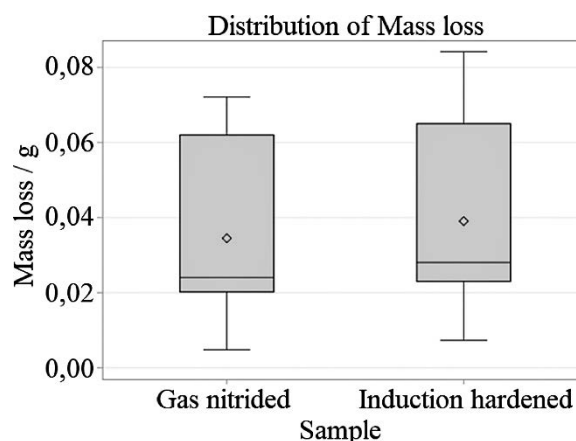
Figure 6 Distribution of mass loss depending on material condition

The Figure 6 shows that induction-hardened samples exhibited a slightly higher mass loss than gas-nitrided samples. Due to lower surface hardness, gas-nitrided samples were better at absorption of the impact energy between the abrasive particles and the worn surface, which led to lesser mass loss of these samples.

The distribution of data referring to mass losses depending on levels of input parameters (sample velocity and impact angle) and referring to material condition is shown in Figures 4, 5 and 6. It is noticed that the distribution of mass loss was the highest when depending on the impact angle and material condition. As seen in the Figure 4, the increase in sample velocity caused the increase in mass loss. Such result is a consequence of increased impact energy between the abrasive particles and the worn surface, which leads to increased mass loss.
