Source / Izvornik: **Metalurgija, 2023, 62, 285 - 288**

# COMPARISON OF WEAR RESISTANCE OF INDUCTION-HARDENED AND GAS-NITRIDED SAMPLES IN THE ABRASIVE MASS MOTION

Preliminary Note – Prethodno priopćenje

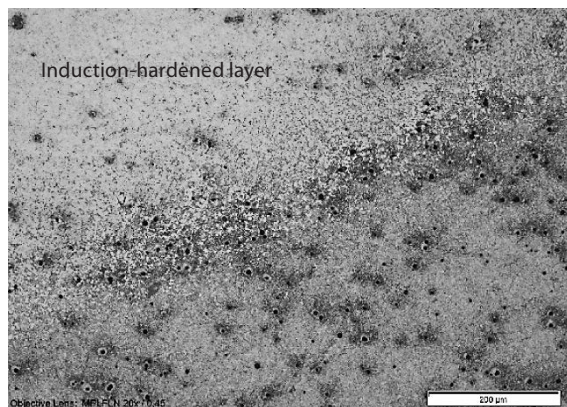
Induction hardening of samples was performed on a HGL-400 device manufactured by Fritz Düsseldorf GmbH, with a shift of 3 m/min and direct water-jet cooling to a room temperature. The Figure 1 presents the microstructure of induction-hardened sample.

**Figure 1** Microstructure of induction-hardened sample

The sample surface hardness was 60 HRC, while the average microhardness at cross section was 678 HV<sub>0,1</sub> measured to a depth of 0,6 mm, which is the effective thickness of the hardened layer.

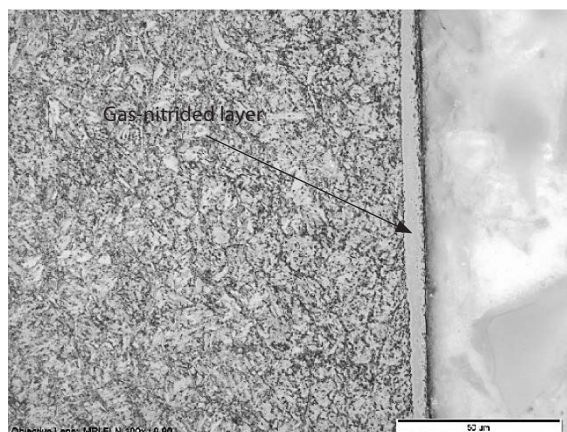
The process was carried out in a gas nitriding furnace in an atmosphere rich in ammonia (NH<sub>3</sub>), at a temperature of 510 °C for 20 hours. Surface hardness of the gas-nitrided samples was 58 HRC. The average microhardness at the sample cross section was 631 HV<sub>0,1</sub>, measured to a depth of 0,3 mm, which is the effective thickness of the hardened layer. Microstructure of the gas-nitrided sample is shown in Figure 2.

**Figure 2** Microstructure of gas-nitrided sample

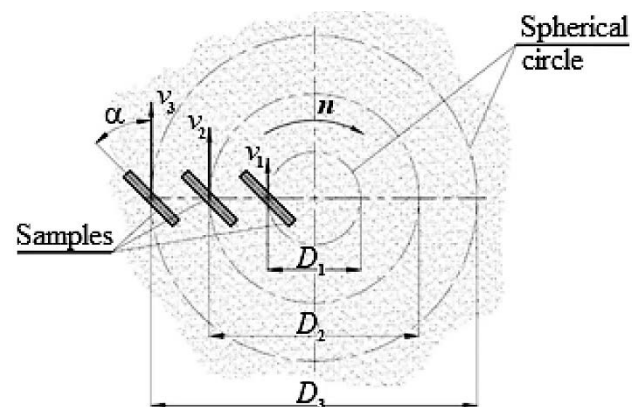
The wear test was performed on an abrasive mass wear device in which samples were immersed in the abrasive mass and rotated at a constant velocity of  $n = 58 \text{ min}^{-1}$ . Motion speed of samples was 1,0, 1,75 and 2,5 m/s, and impact angles of abrasive mass and worn surface were 30° and 60° ( $\alpha$  – the angle show in figure 3). Stated parameters were selected because of their similarity with common agrotechnical methods of tillage. The Figure 3 presents kinematic quantities in the wear experiment, by showing that the samples were placed on a precisely determined diameter of inscribed circle ( $D$ ), which they move along, and that the sample velocity ( $v$ ) was calculated according to the expression for peripheral velocity.

**Figure 3** Schematic presentation of kinematic quantities in the experiment

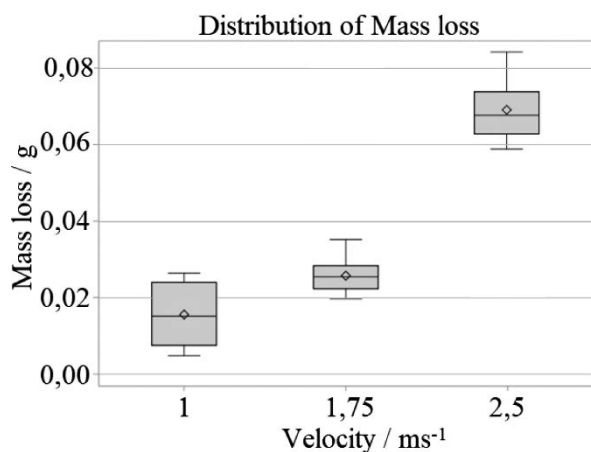
The distribution of data referring to mass losses depending on levels of input parameters (sample velocity and impact angle) and referring to material condition is shown in Figures 4, 5 and 6. It is noticed that the distribution of mass loss was the highest when depending on the impact angle and material condition. As seen in the Figure 4, the increase in sample velocity caused the increase in mass loss. Such result is a consequence of increased impact energy between the abrasive particles and the worn surface, which leads to increased mass loss.

Figure 4 Distribution of mass loss depending on sample velocity

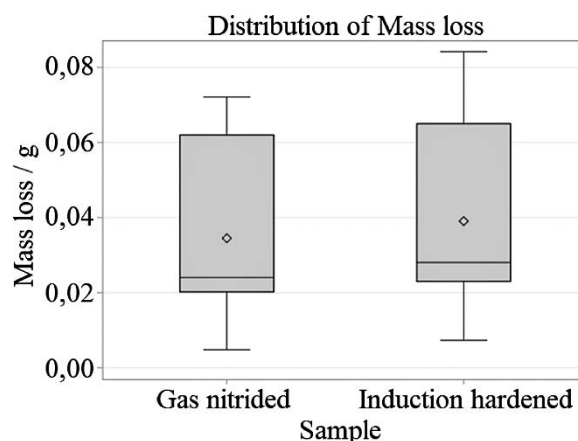
Figure 6 Distribution of mass loss depending on material condition

The Figure 6 shows that induction-hardened samples exhibited a slightly higher mass loss than gas-nitrided samples. Due to lower surface hardness, gas-nitrided samples were better at absorption of the impact energy between the abrasive particles and the worn surface, which led to lesser mass loss of these samples.

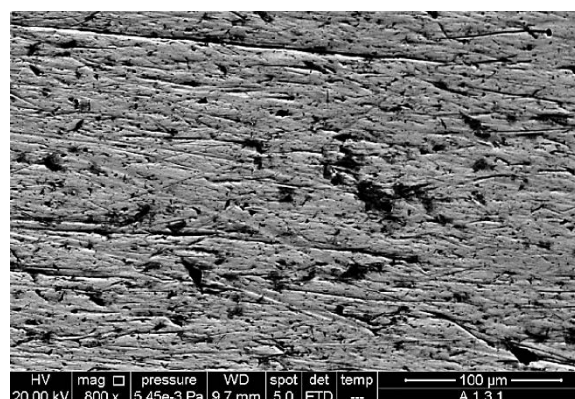
Figure 7 SEM wear of induction-hardened samples

The Figures 7 and 8 show scanning electron microscopy (SEM) recording of the wear paths, proving that induction-hardened samples had higher mass loss than gas-nitrided samples, as well as higher mass loss at the highest sample velocity (2,5 m/s) and at lower impact angle. As presented in the Figure 7, clear evidence of abrasive wear was present in form of tiny rills and holes.

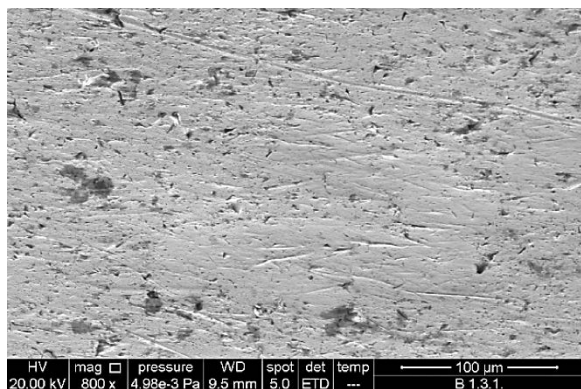
**Figure 8** SEM wear of gas-nitrided samples
